Accotink Creek Watershed

Why Restore Wakefield Run?

Wakefield Run Restoration

Danbury Stream and Flag Run Stream Restorations:

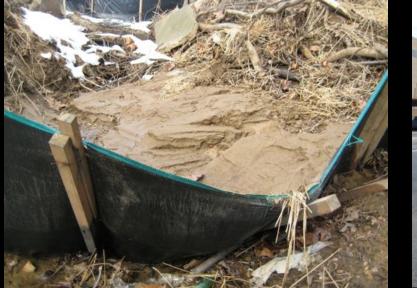
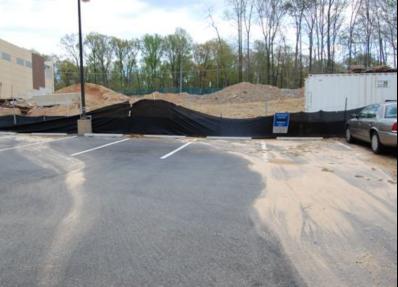
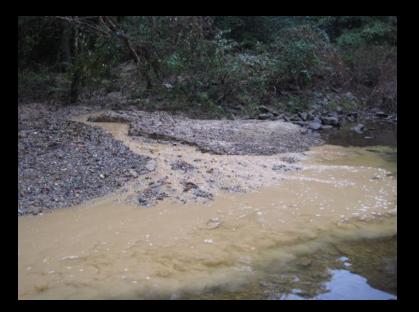
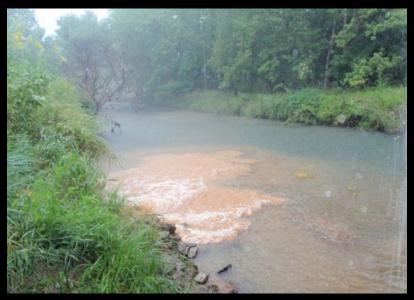
Large amounts of sediments are washed into Accotink Creek during rain events from construction sites if erosion and sediment control practices are inadequate.

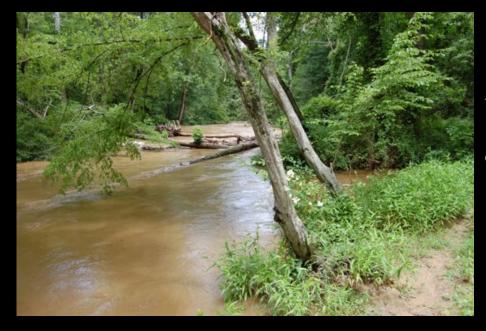
Impervious surfaces channel rain water into the stormwater system, and then Accotink Creek. Large rain events result in large amounts of water flowing quickly downstream. This erodes the stream banks, both the sides and the bottom. 100 years ago, Accotink Creek was a shallow "V". Now, it's a deeply incised "U"- a channel with steep banks.

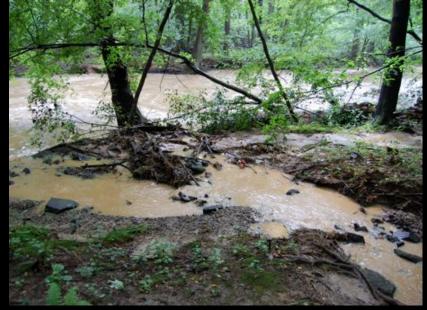
Silt and sediment washed into the Creek from construction sites, or eroded from the banks during rain events, smothers the aquatic life in the creek. It is toxic for many beings, like smoke is toxic for us.

Fine particles of silt can take weeks to settle out of the water, and sediment that accumulates on the bottom smothers macroinvertebrates that live among the rocks and pebbles.

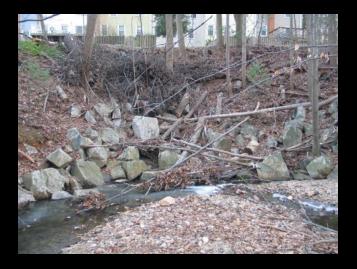
Tree undercut by erosion

Eroding streambank

Trail threatened by erosion

Both streams have been severely eroded by stormwater runoff, creating steep channelized banks, undercutting trees, exposing sewer lines and mains, and causing significant sediment contributions to Accotink Creek and Lake Accotink. In addition, the erosive widening of both streams is threatening surrounding homeowner properties, and Danbury Stream will imminently wash away a popular community walking trail and footbridge.

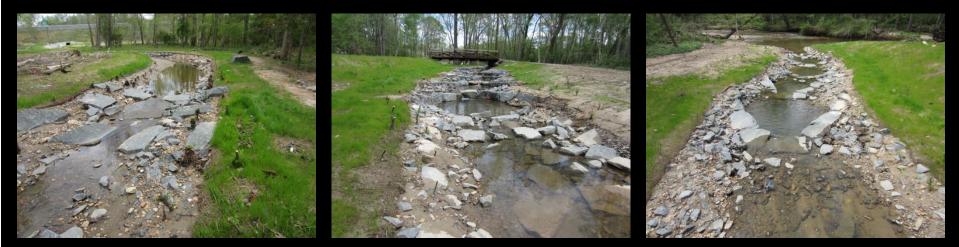
Examples of Natural Channel Design from the Wakefield Run Restoration

- 1. Grading and rerouting stream channels to restore a more natural stream hydrology. Stabilizing and strengthening steep eroding stream banks with rock and log structures to reduce sediment erosion and protect community infrastructure and homeowner properties from erosion-related damage.
- 2. Installing grade controls and plunge pools to slow stormwater velocity and reduce its erosive power.
- 3. Replanting the floodplain with native species to stabilize stream banks, reduce stormwater runoff and erosion, and create native habitat.
- 4. Replacing turf grass with native plantings to reduce stormwater runoff and create natural habitat.

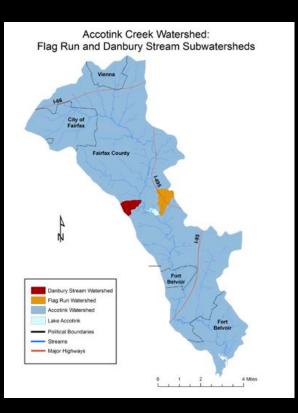
Flag Run and Danbury Stream Imperviousness
